# Bear Brook Watershed Study – Fluvial Geomorphology Characterization Report

January 2025

## Summary of Findings

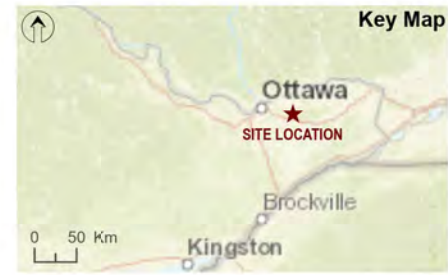
- Reach Break
- Flow Direction
- ~ Bear Brook Main Branch
- Study Area
- ~ Watercourse<sup>1</sup>
- Bear Brook Watershed Boundary

Palmer was retained by South Nation Conservation (SNC) to assess the fluvial geomorphology and landslide distribution along Bear Brook (**Figure 1**). Fluvial geomorphological processes along Bear Brook reflect a combination of local geology, natural meander adjustments, anthropogenic alterations, and landsliding. SNC, in collaboration with the City of Ottawa, has commissioned this assessment recognizing that slope and erosion hazards may unknowingly pose a risk to human life, property and/or infrastructure if not properly investigated and characterized. The findings of the assessment will be incorporated into the Bear Brook Watershed Characterization Study and support planning-related decisions within the Bear Brook watershed.

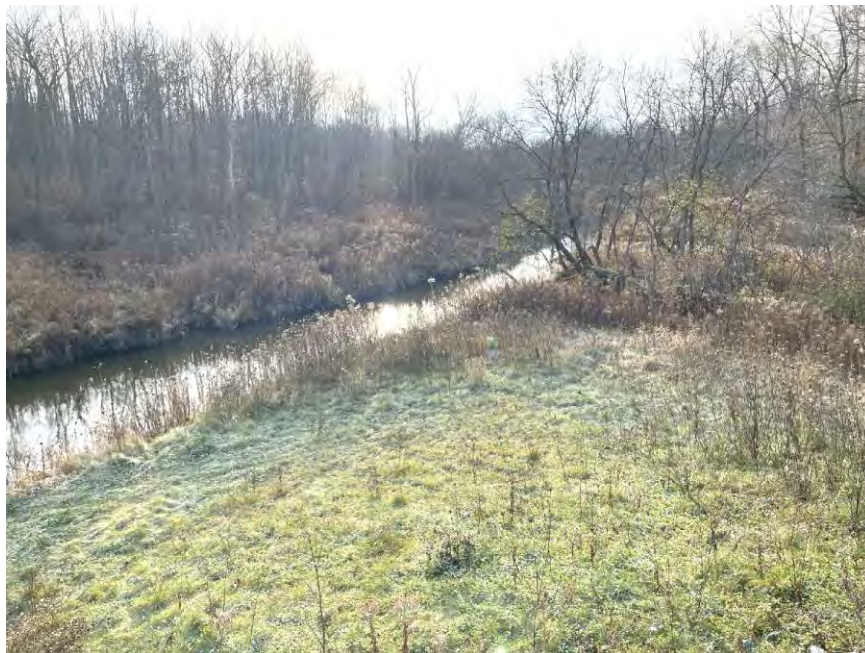
*Photo 1. Representative photograph (looking upstream) of Reach 1 flowing within a defined, forested valley formed through channel incision of near-shore sands and deltaic sands.*

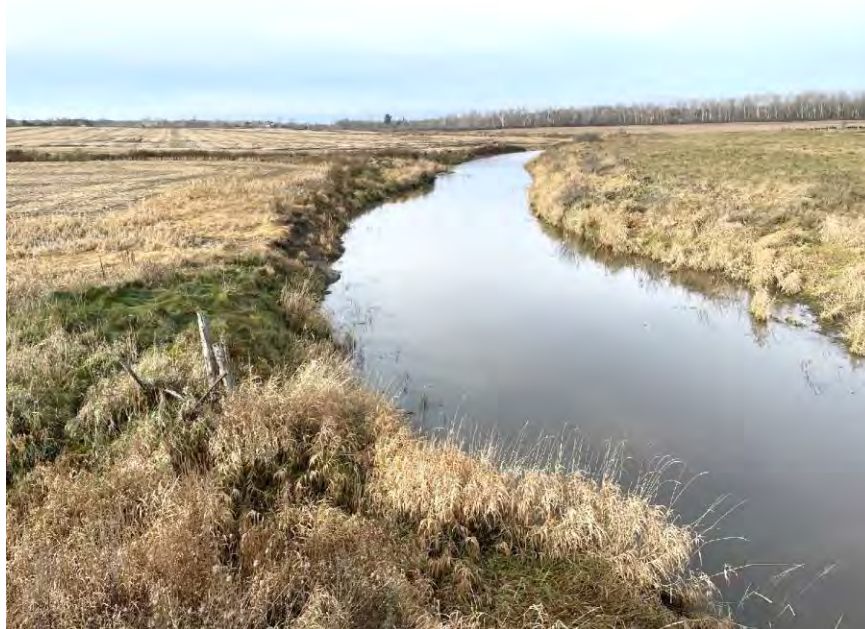
***Photo 2. Representative photograph (looking upstream) of Bear Brook within the Mer Bleue paleochannel upstream of the Vars-Winchester Esker (i.e. Reach 2 through Reach 4). The channel is unconfined, with good access to its floodplain, and the riparian vegetation has been largely cleared.***

Riparian vegetation along Reaches 2, 3, and 4 has been extensively cleared, mostly for agricultural purposes. A riparian vegetation buffer is present along the contemporary valleys of Reach 1 and Reaches 5 through 9. Occasionally debris jams were observed along these reaches. The tablelands above the contemporary valleys are dominated by agricultural activities. Gravels and lag cobble and boulder deposits were locally observed in Reach 1 and Reach 5. The remaining reaches have silt and fine-sand bed material. Bank materials are dominated by clay, silts, and fine sands. Anthropogenic rock weirs were observed beneath numerous vehicle crossings.

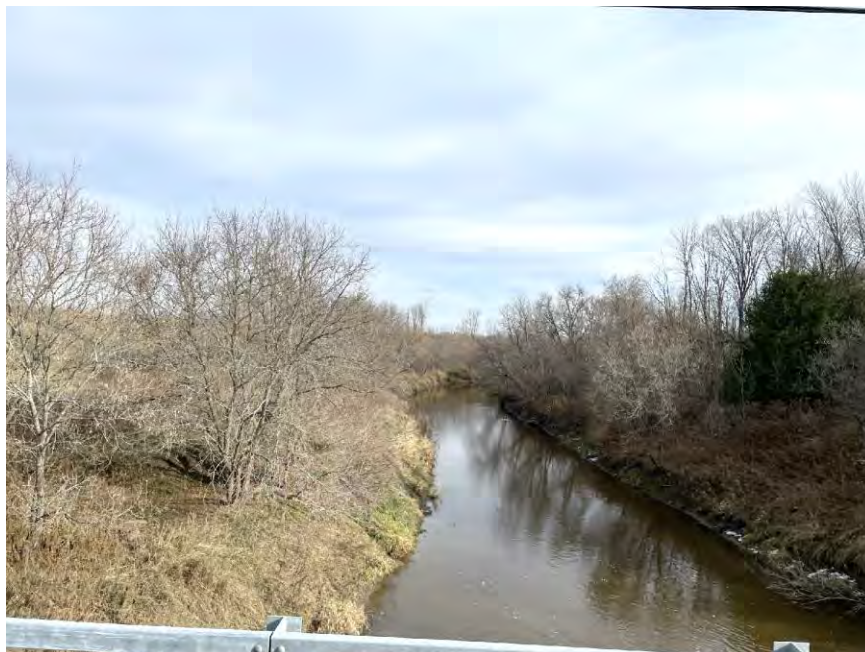
***Photo 3. Representative photograph (looking downstream) of Bear Brook downstream of the Vars-Winchester Esker (i.e. Reach 5 through Reach 9). The channel has incised through the paleochannel deposits leading to channel confinement, lack of floodplain access, and localized landsliding.***

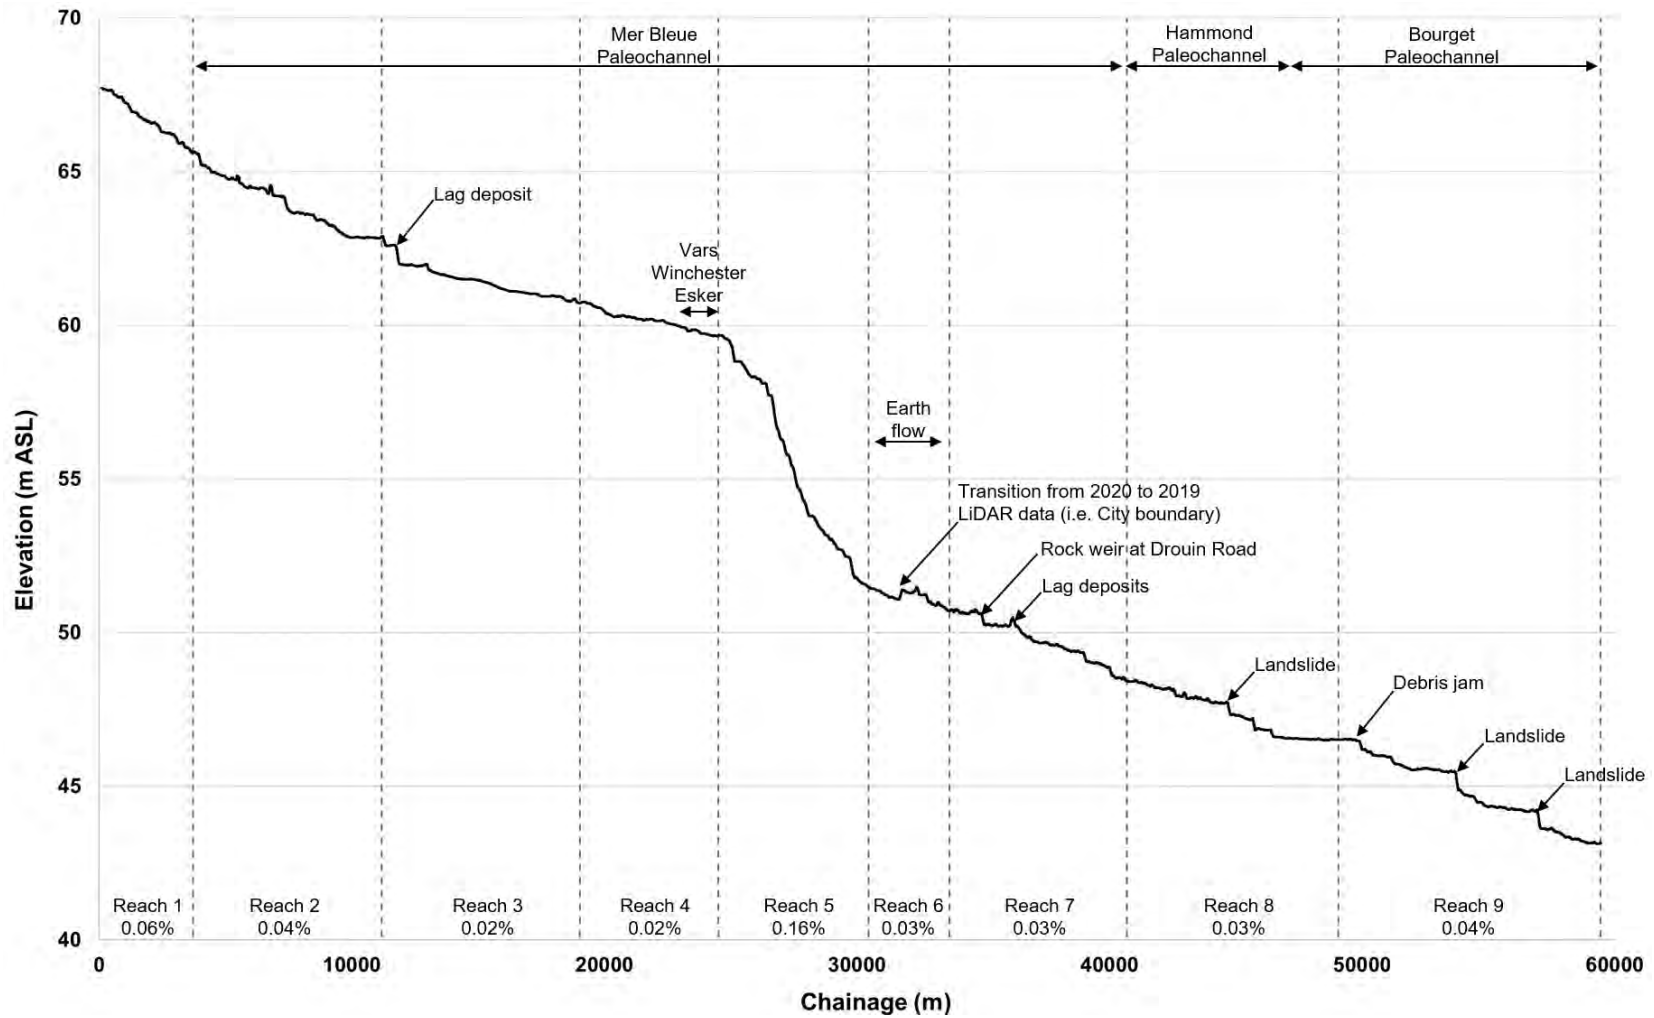
**Figure 4. Longitudinal profile of Bear Brook.** The faint grey line represents elevations extracted every 1 m along the 2017 water surface centreline. The dark black line represents a 100 m moving average that helps smooth inherent noise in LiDAR data (e.g. apparent downstream rise in water surface). The vertical dashed lines divide reaches, also shown on Figure 1, with their average gradients shown as percentages. The extents of the paleochannels are shown on Figure 1 and Figure 2. The Vars-Winchester Esker is a prominent vertical (grade) control that impacts profile development both upstream and downstream. The profile is locally controlled by debris jams, landsliding, and anthropogenic rock weirs.

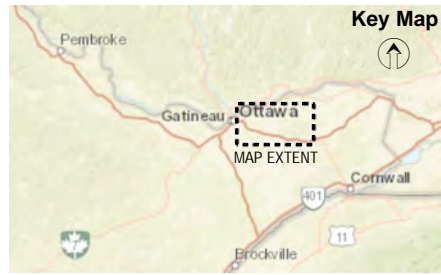
- Esker (partly buried; approximate)<sup>2</sup>
- Bear Brook Watershed Boundary

1. Ontario Hydro Network (LIO, 2024)  
 2. The approximate extent of the Vars-Winshester Esker in the vicinity of Bear Brook is shown on the map. The esker extends further north and south than shown

- **Vars-Winchester Esker** – The sand and gravel core of the Vars-Winchester Esker acts as a prominent grade control along Bear Brook. Upstream of the esker, Bear Brook has been unable to incise into Champlain Sea sediments. The bed of the channel is only slightly below its floodplain (i.e., unconfined), resulting in a wide floodplain adjacent to the channel. Downstream of the esker, Bear Brook has incised into Champlain Sea sediments as it flows to its confluence with the South Nation River. Channel incision has created a contemporary valley, which contains flood flows and appears prone to small landslides.

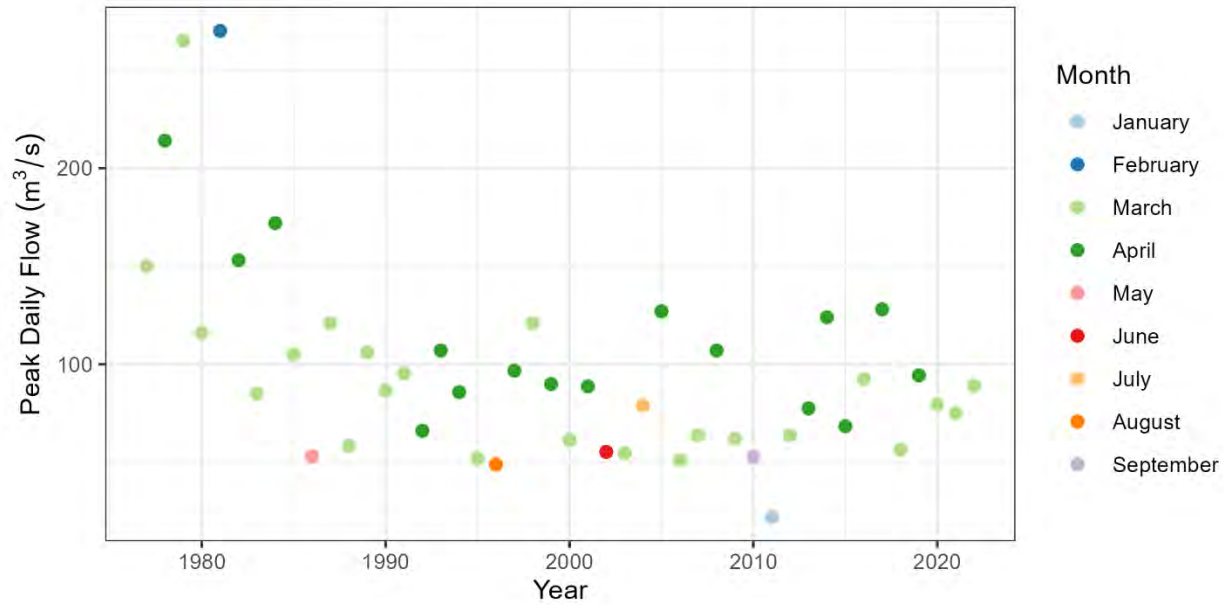
Figure 8. Long-term timeseries of peak streamflow magnitude and timing for Bear Brook [02LB008]

The timeseries of annual daily peak flow for Bear Brook indicates that peak flow magnitude is decreasing over time at a statistically significant rate (**Figure 8, Table 9**). Visual interpretation of Figure 1.3 suggest that this change was most prevalent in the first decade of record and has stabilized from the 1990s to present day. The cause of this reduction is unknown, but it may be due to a reduction in snowpack accumulation during winter months, long-term weather patterns (e.g. atmospheric teleconnections), land-use change within the watershed, and/or other environmental factors. Decreasing flood magnitudes may contribute to the relatively modest migration rates. Annual peak flow timing has historically occurred in March and April. In some more recent years, annual peak flows occurred during the summer months. This trend is statistically significant (**Figure 8, Table 9**). The later peak flows further implies they are driven less by decreasing winter snowpacks and, instead, are increasingly affected by summer precipitation events. High flows occurring later in the year allows vegetation to increase bank strength (i.e. reduce erosion potential) and may reduce the likelihood of ice jamming.

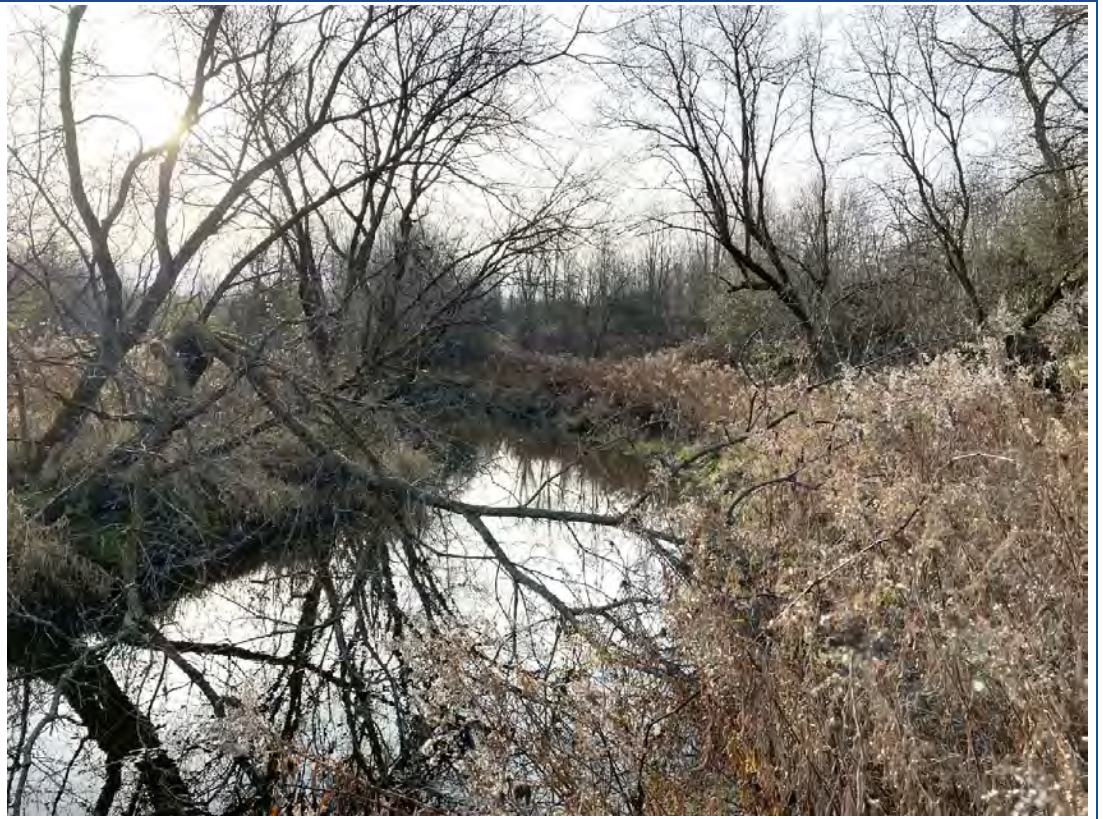
<i>Photo #:</i> <b>2</b>	<i>Date:</i> 11/15/2023
<i>Direction Photo Taken</i>	S
<p><b>Description</b></p> <p><b>Reach 1</b> – Looking upstream at a debris jam near Piperville Road.</p>

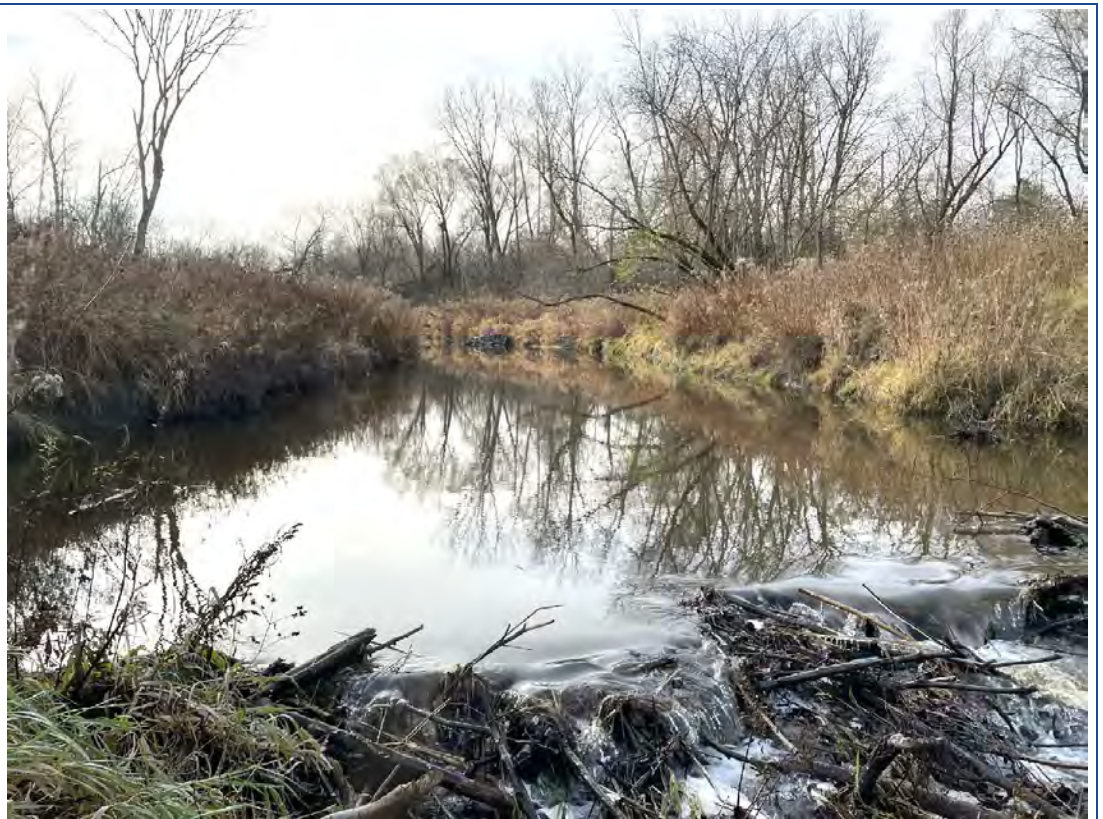
<i>Photo #:</i> <b>3</b>	<i>Date:</i> 11/15/2023
<i>Direction Photo Taken</i>	E
<p><b>Description</b></p> <p><b>Reach 2</b> – Looking downstream from Hall Road. The channel was anthropogenically straightened between 1945 and 1975.</p>

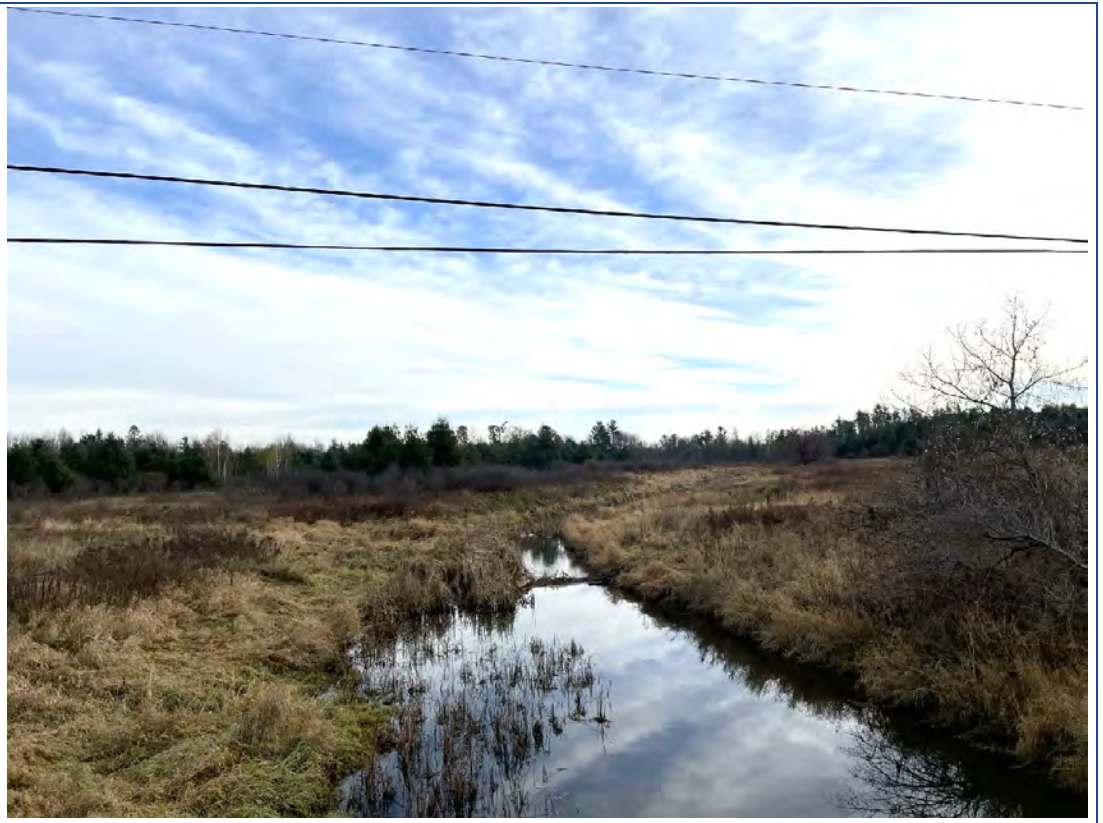
<i>Photo #:</i> <b>4</b>	<i>Date:</i> 11/15/2023
<i>Direction Photo Taken</i>	W
<p><b>Description</b></p> <p><b>Reach 2</b> – Looking upstream from Carlsbad Lane. Shrub and tree riparian vegetation has been removed.</p>

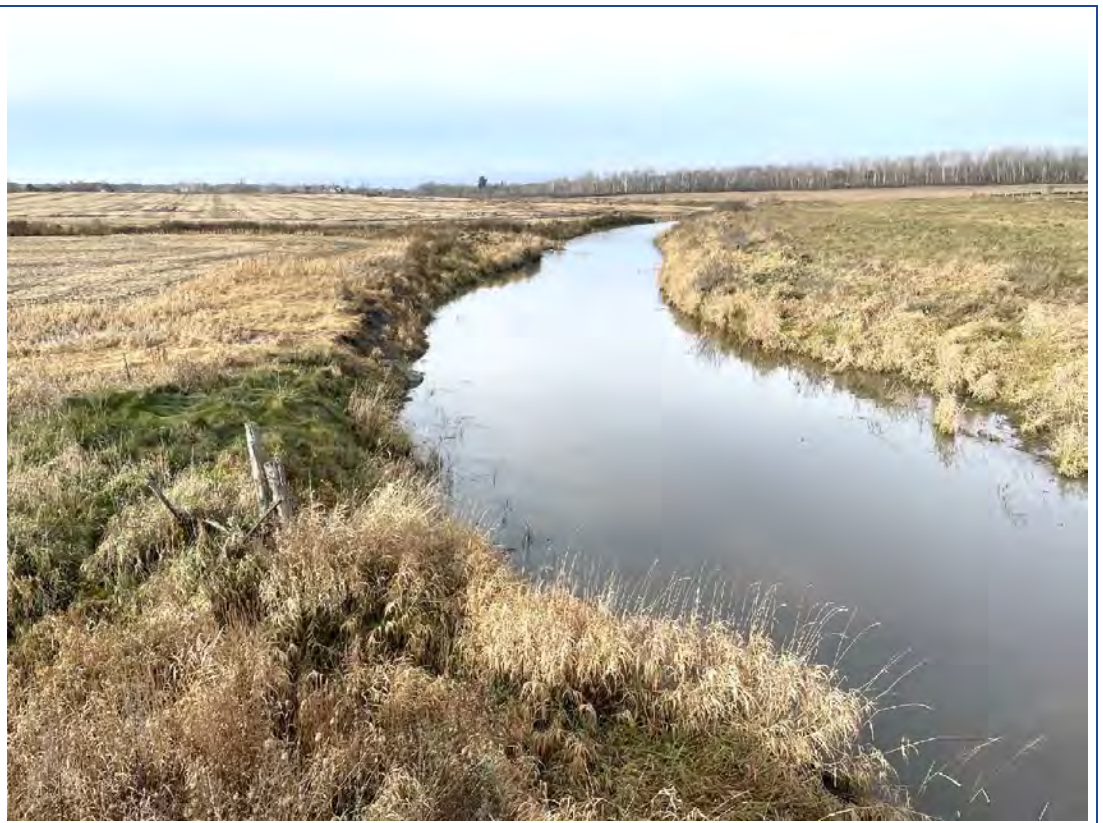
<i>Photo #:</i> <b>5</b>	<i>Date:</i> 11/15/2023	 
<i>Direction Photo Taken</i>	W	
<p><b>Description</b></p> <p><b>Reach 3</b> – Looking upstream from Milton Road. The banks are locally slumping.</p>

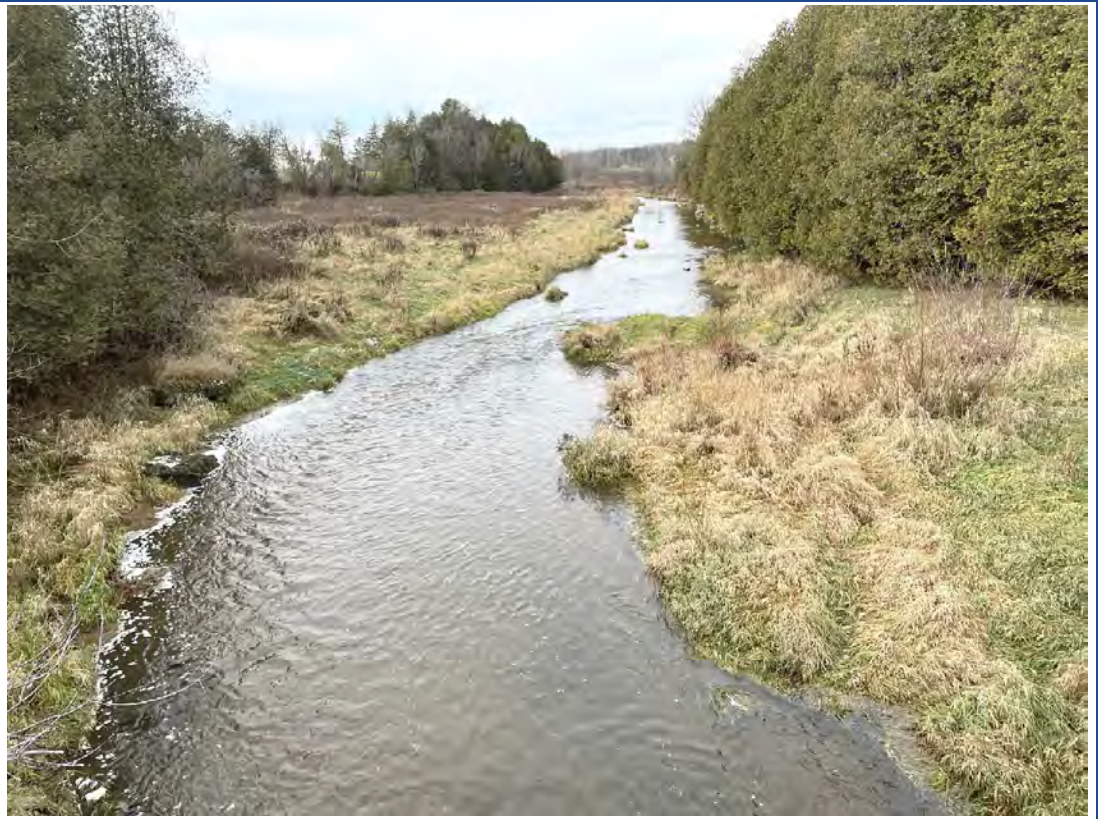
<i>Photo #:</i> <b>10</b>	<i>Date:</i> 11/15/2023
<i>Direction Photo Taken</i>	S
<p><b>Description</b></p> <p><b>Reach 5</b> – Looking downstream from Russell Road. The channel has become partially confined downstream of the Vars-Winchester Esker.</p>

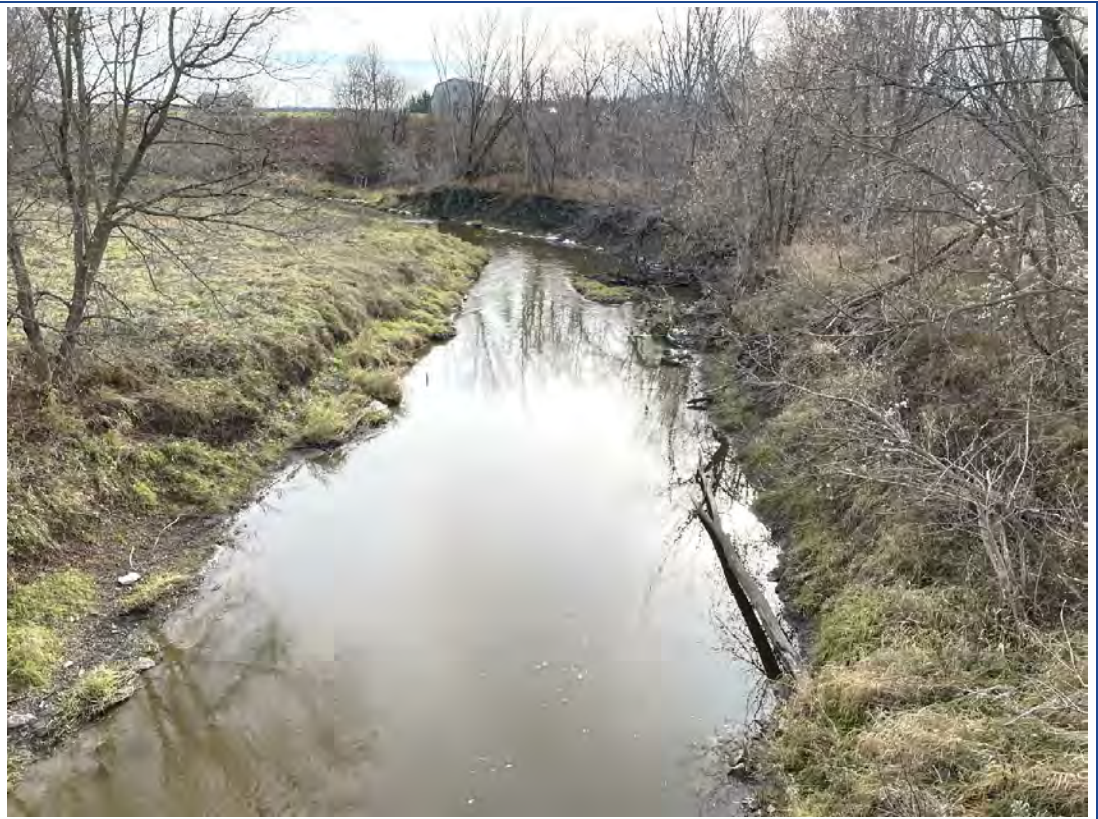
<i>Photo #:</i> <b>11</b>	<i>Date:</i> 11/15/2023
<i>Direction Photo Taken</i>	W
<p><b>Description</b></p> <p><b>Reach 6</b> – Looking upstream from Indian Creek Road. Anthropogenic rock has been placed on the banks.</p>

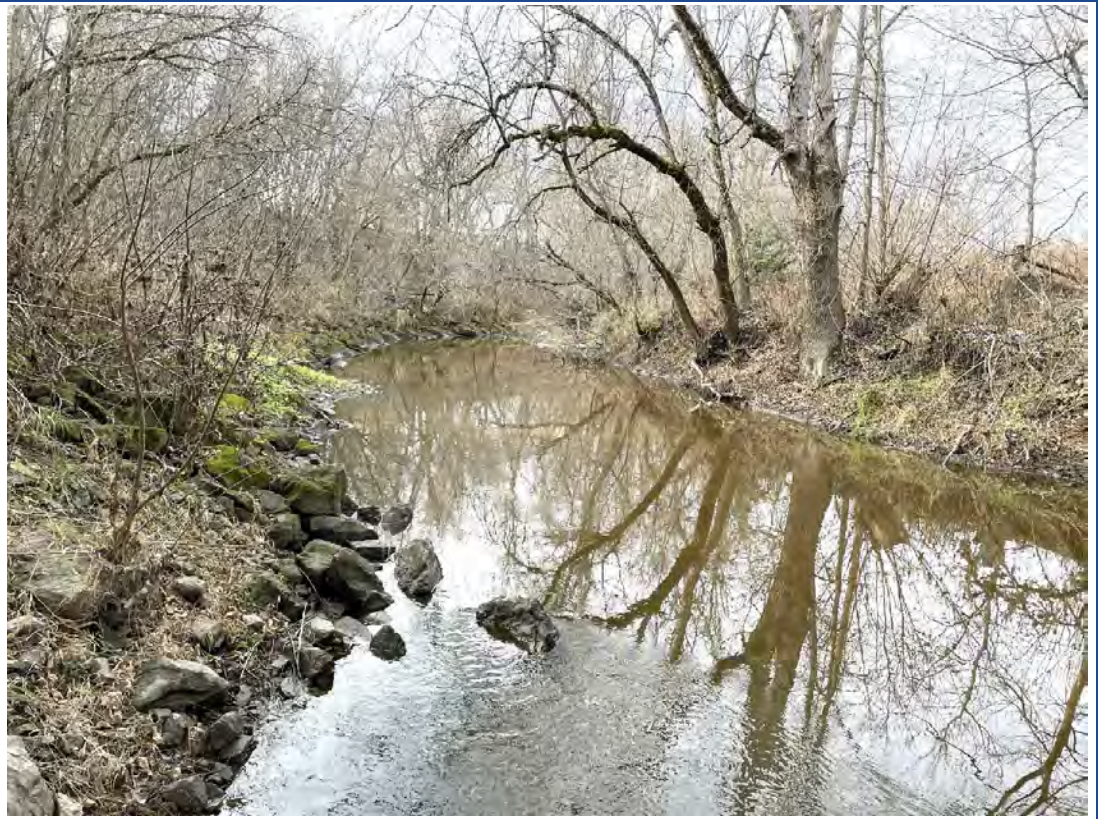
<i>Photo #:</i> <b>12</b>	<i>Date:</i> 11/15/2023
<i>Direction Photo Taken</i>	E
<p><b>Description</b></p> <p><b>Reach 6</b> – Looking downstream from Indian Creek Road. Leaning and fallen trees are present.</p>

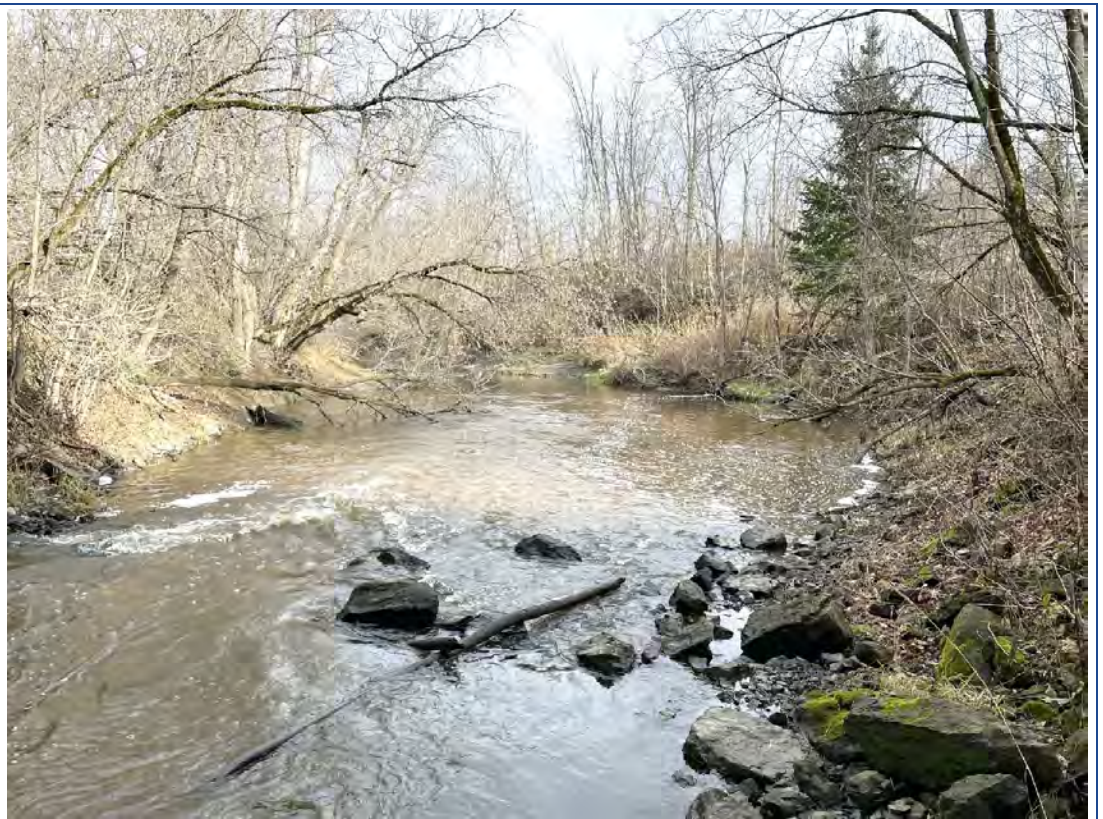
<i>Photo #:</i> <b>13</b>	<i>Date:</i> 11/15/2023
<i>Direction Photo Taken</i>	N
<b>Description</b>	
<p><b>Reach 7</b> – Rock weir beneath Drouin Road. Several similar rock weirs were observed at road crossings along Bear Brook.</p>

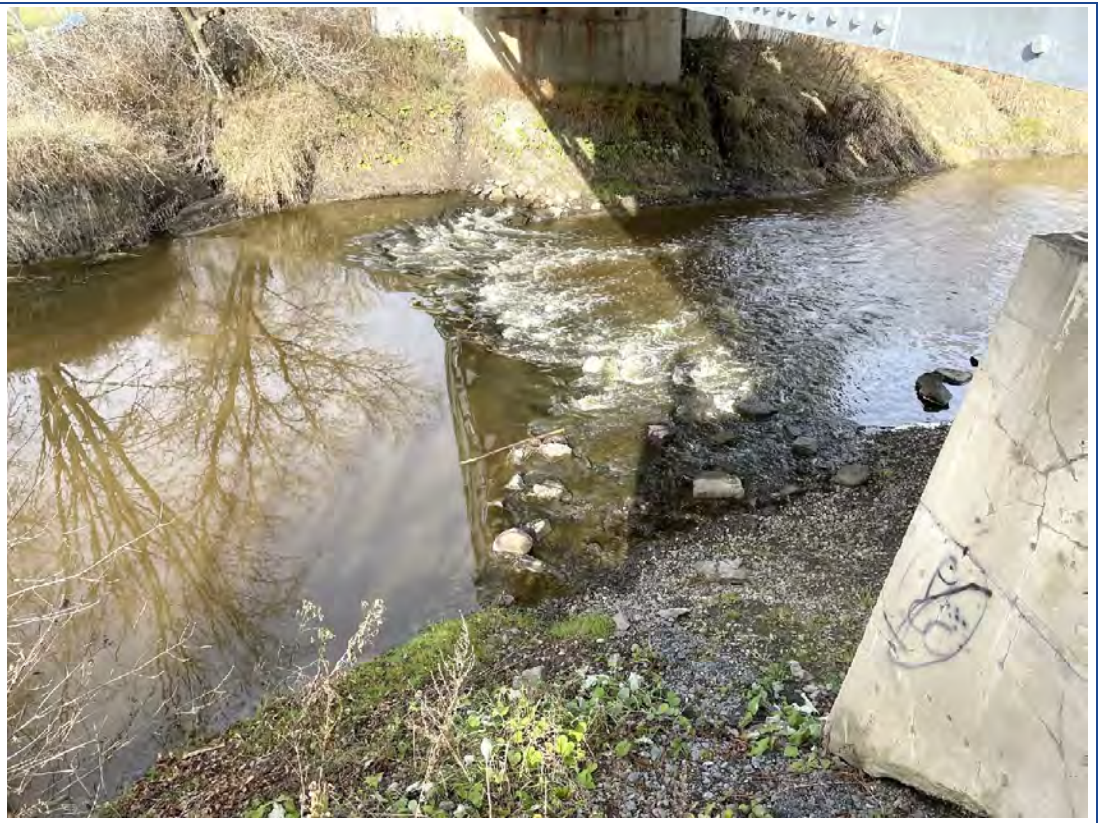
<i>Photo #:</i> <b>14</b>	<i>Date:</i> 11/15/2023
<i>Direction Photo Taken</i>	E
<b>Description</b>	
<p><b>Reach 7</b> – Looking downstream from Drouin Road. The channel is locally overwidened downstream of the undersized crossing and rock weir.</p>

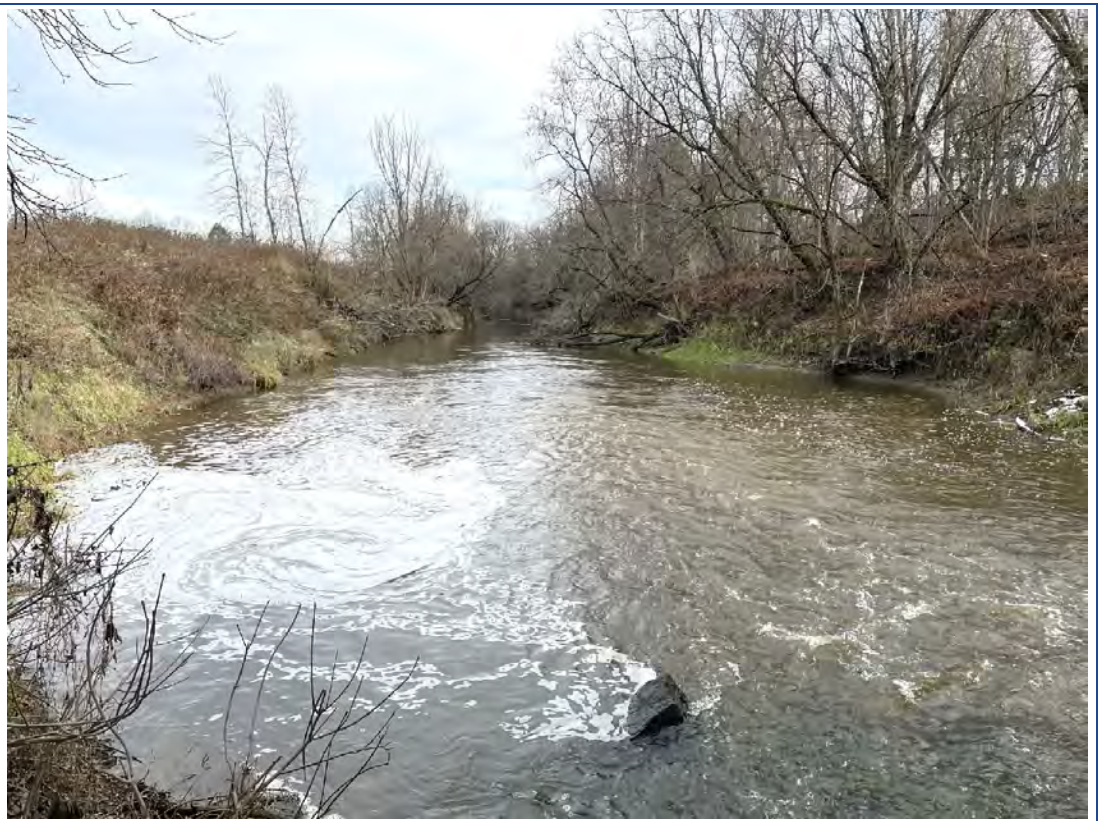
<i>Photo #:</i> <b>15</b>	<i>Date:</i> 11/15/2023
<i>Direction Photo Taken</i>	N
<b>Description</b>	
<p><b>Reach 8</b> – Looking upstream at Champlain Road. This is the location of the Water Survey of Canada Gauge (02LB008) for Bear Brook (not shown).</p>

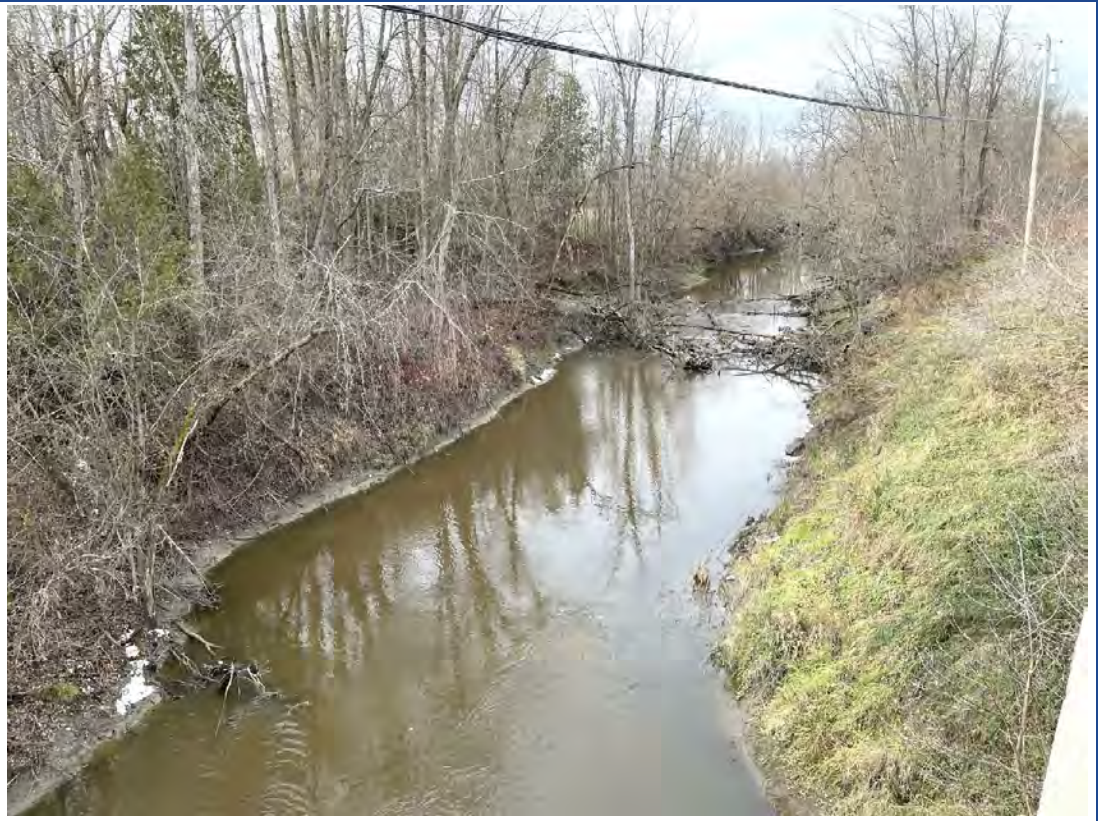
<i>Photo #:</i> <b>16</b>	<i>Date:</i> 11/15/2023
<i>Direction Photo Taken</i>	E
<b>Description</b>	
<p><b>Reach 8</b> – Looking downstream from Ettyville Road. Bear Brook is entrenched such that it cannot readily access its floodplain during flood events.</p>

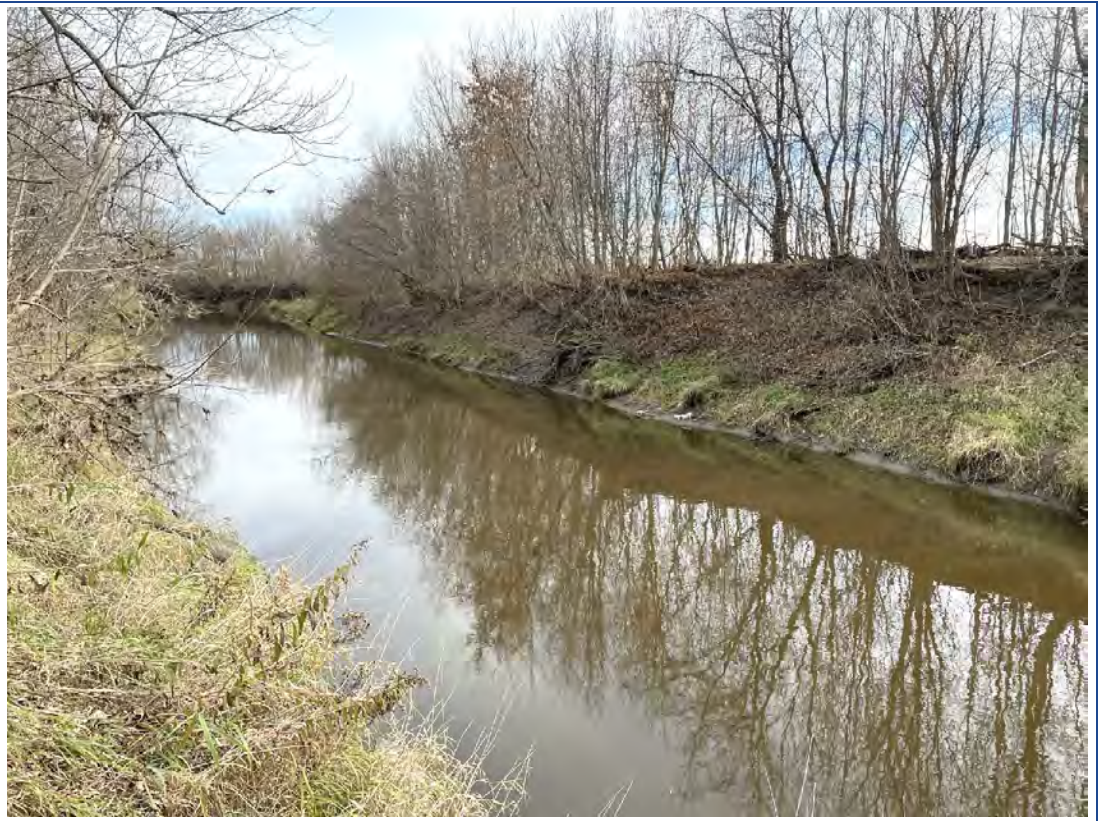
<i>Photo #:</i> <b>17</b>	<i>Date:</i> 11/15/2023	 
<i>Direction Photo Taken</i>	E	
<p><b>Description</b></p> <p><b>Reach 9</b> – Looking downstream from ETTYVILLE Road. Both banks are relatively steep due to ongoing channel incision.</p>

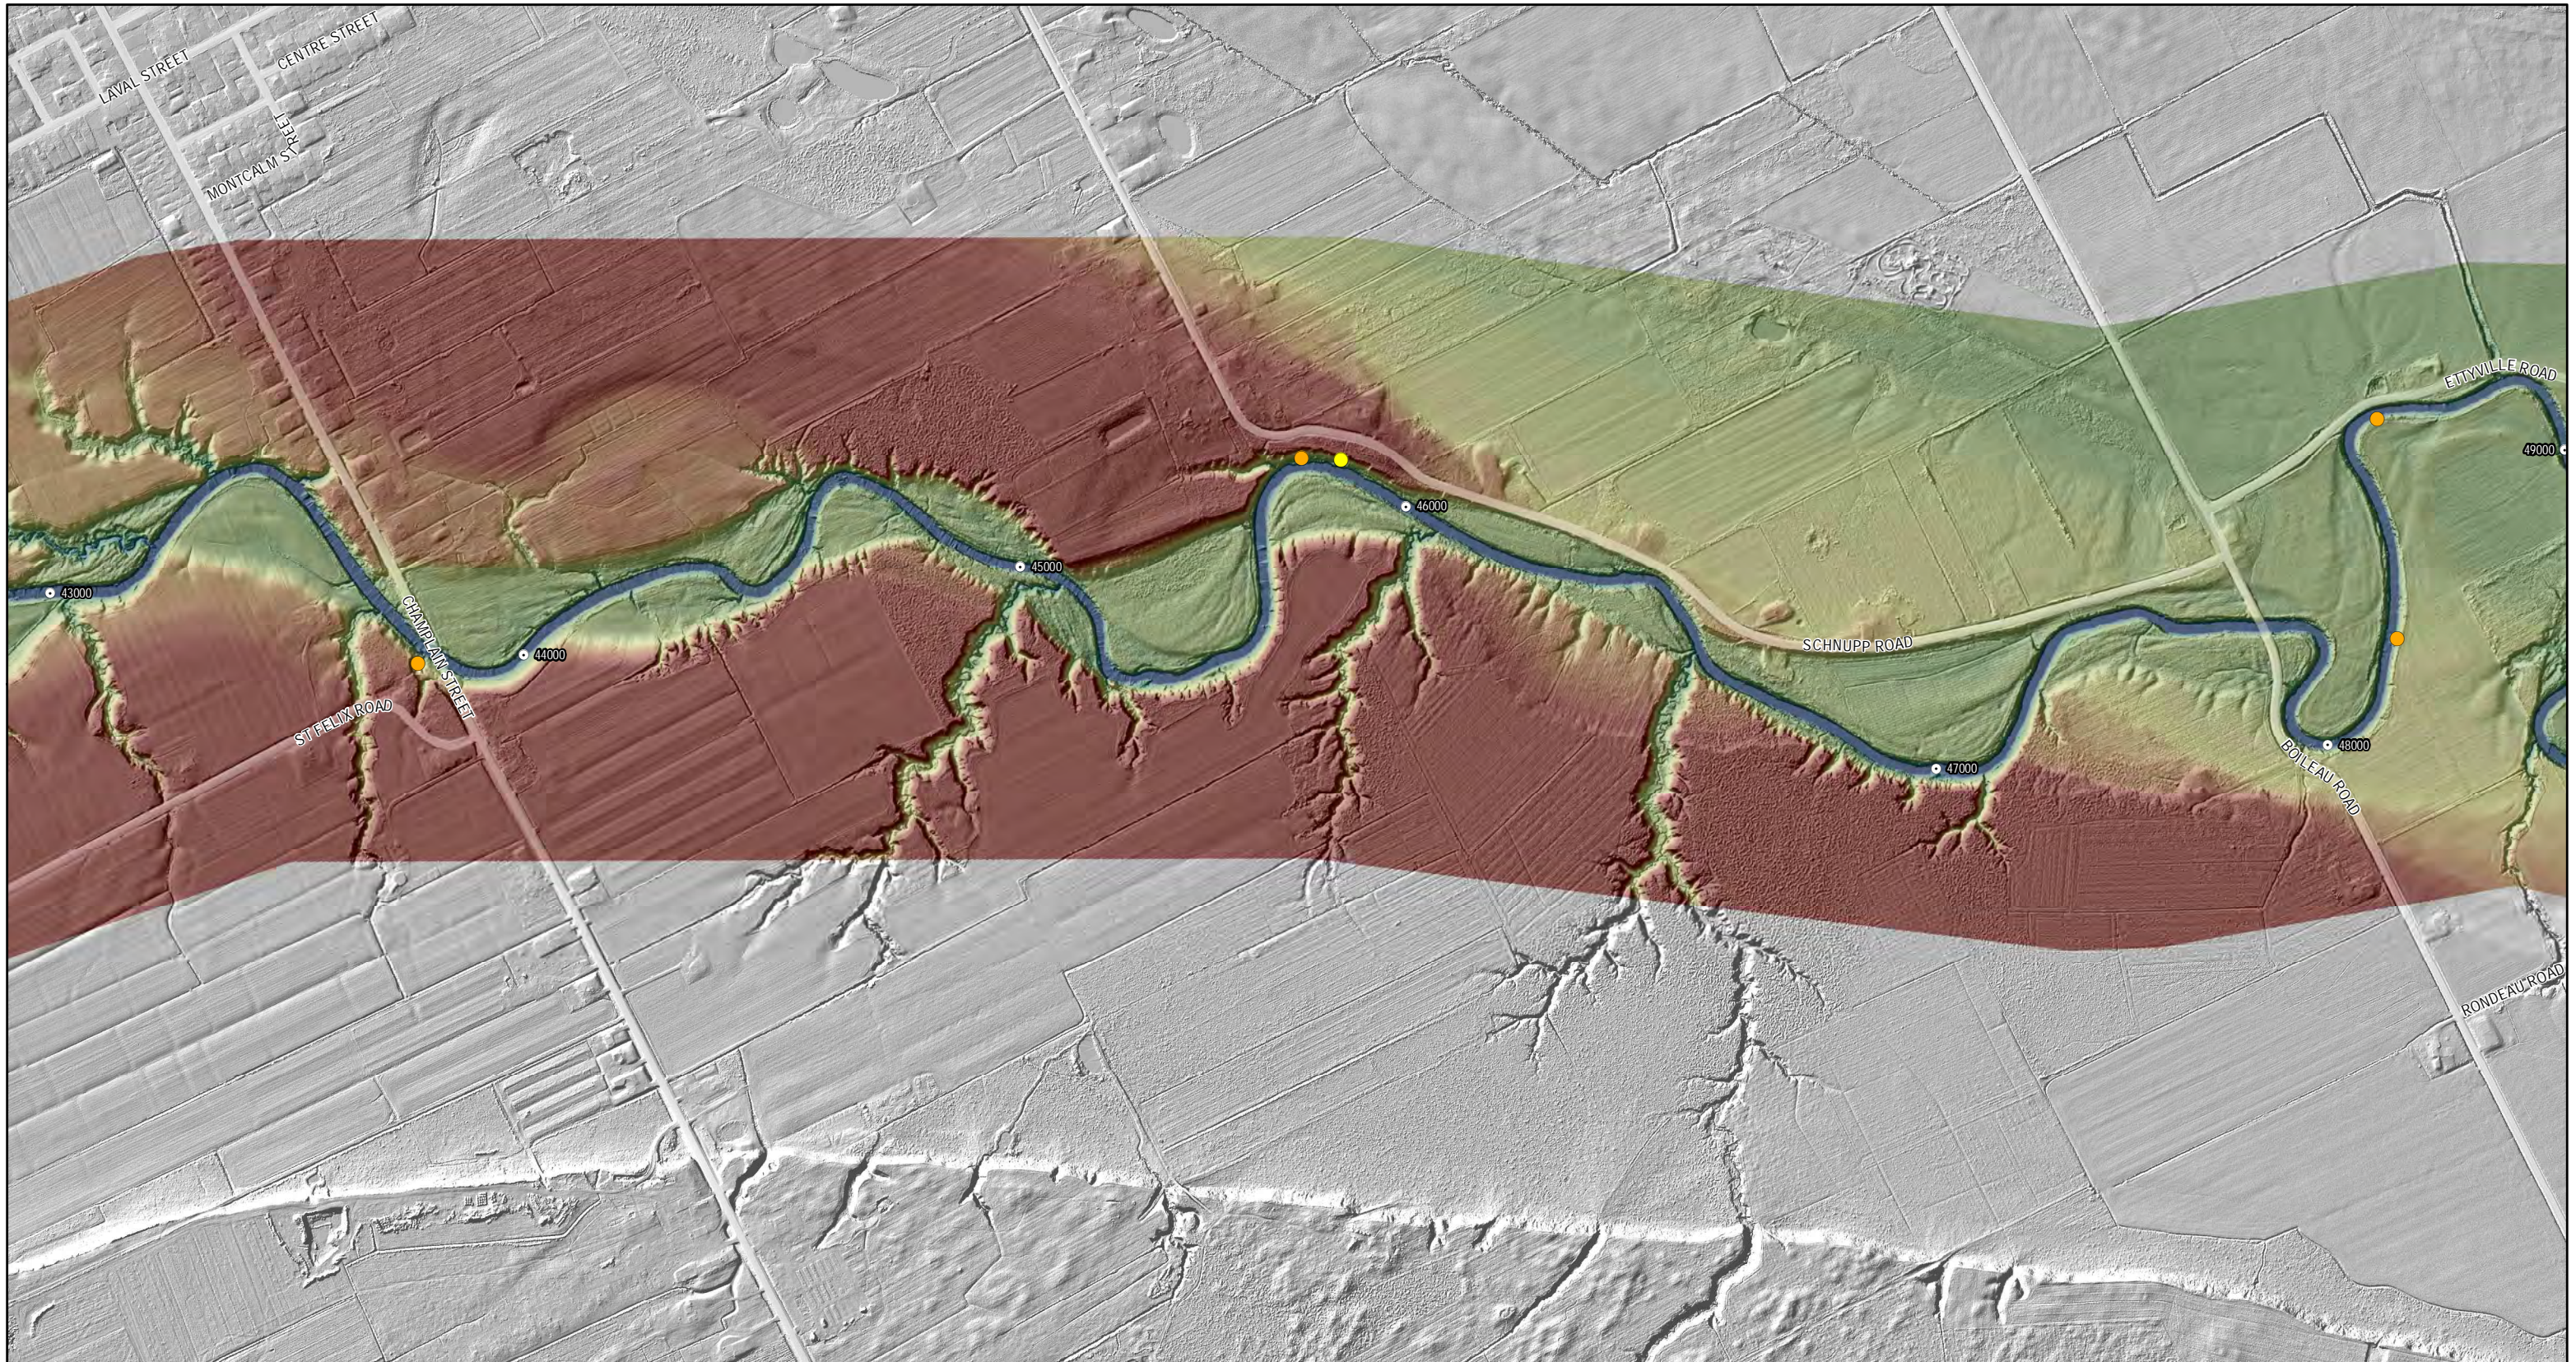
- Possible Landslide
- Probable Landslide
- River Chainage (m)<sup>3</sup>

1. Relative Elevation Model (REM) created using 1 m resolution 2019-20 Lidar-derived Digital Terrain Model.  
 2. Bear Brook is 0 m relative elevation.  
 3. River Chainage is based on 2019-20 Lidar-derived Digital Terrain Model planform.
